# Bourne Hard Court Evaluation and Rehabilitation Plan

This report is submitted to drive improvements in the basketball and racquet sports facilities in the Town of Bourne. Racquet sports to include both tennis and pickleball.

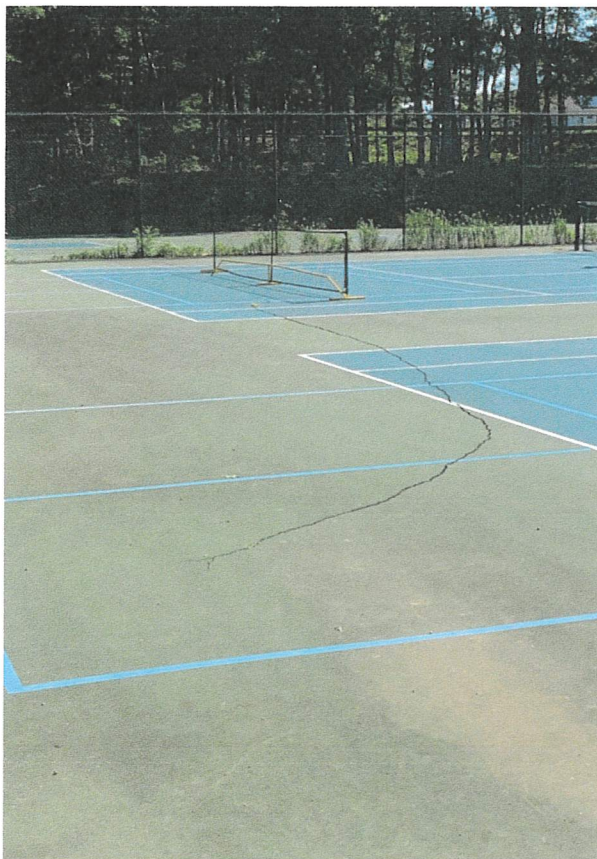
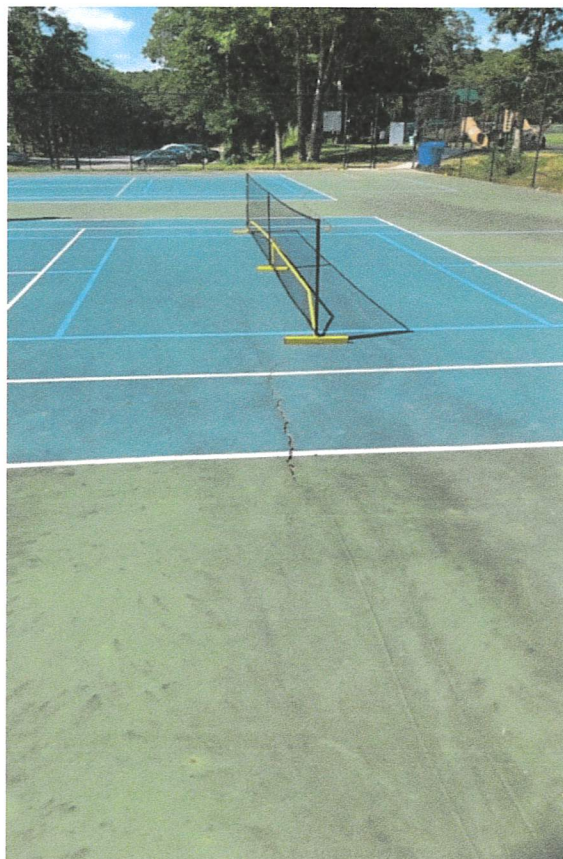
Clarke Field Tennis courts are in fair condition. There are 455 linear feet of cracks that need rehabilitation. This includes some previous repairs that will have to be removed to affect the new refurbishing. The fences surrounding all three courts are in good condition. The courts have some cracking where it is obvious the asphalt is starting to fail but is still at a point where the condition could be extended several years by rehabilitating the surface and recoating. Expected life remaining in the courts is less than five years. The 2021 budget pricing cost to rehabilitate these two courts is \$54,000.

On a ten-point scale:

Asphalt Condition: 4

Surface condition: 5

Fence condition: 8

Parking: 10

Demand: 8

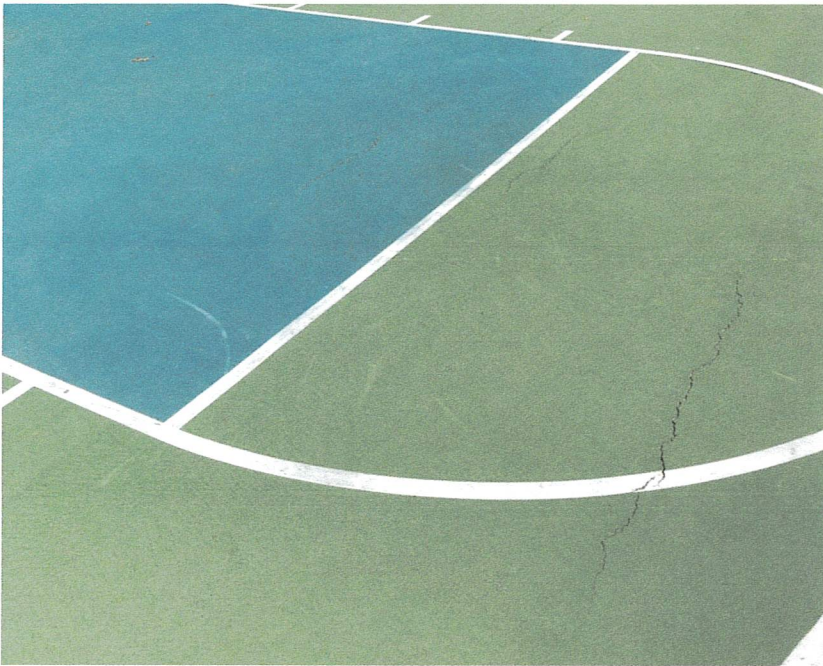
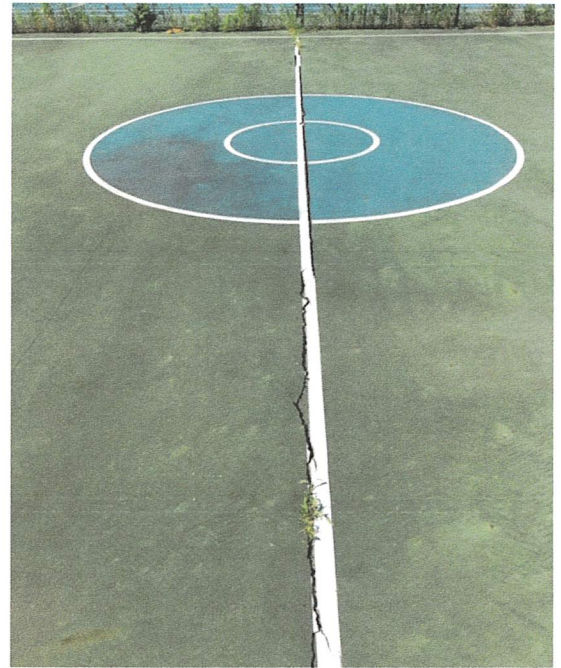
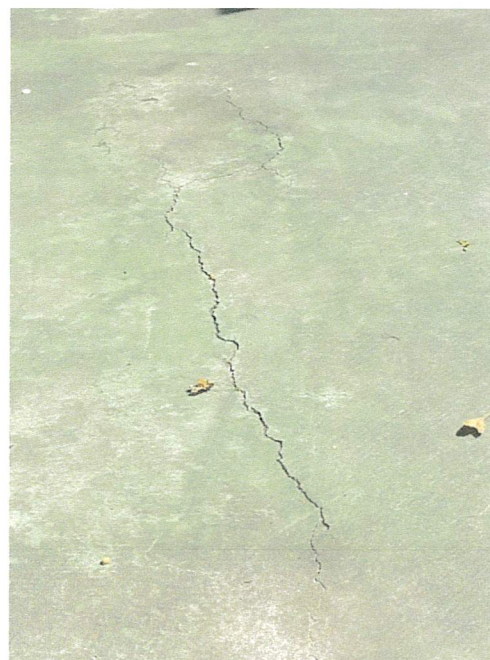
The Clarke Field Basketball court is similar to the adjacent tennis courts. The surface is cracking and there is 214 linear feet of cracks that require repair. The asphalt is the same age as the tennis courts and is failing but still worth rehabilitating and the Town should expect to get another five years from it after refurbishing. The 2021 budget pricing cost to rehabilitate this basketball court is \$25,000.

On a ten-point scale:

Asphalt Condition: 4

Surface condition: 5

Fence condition: 8

Parking: 10

Demand: 8

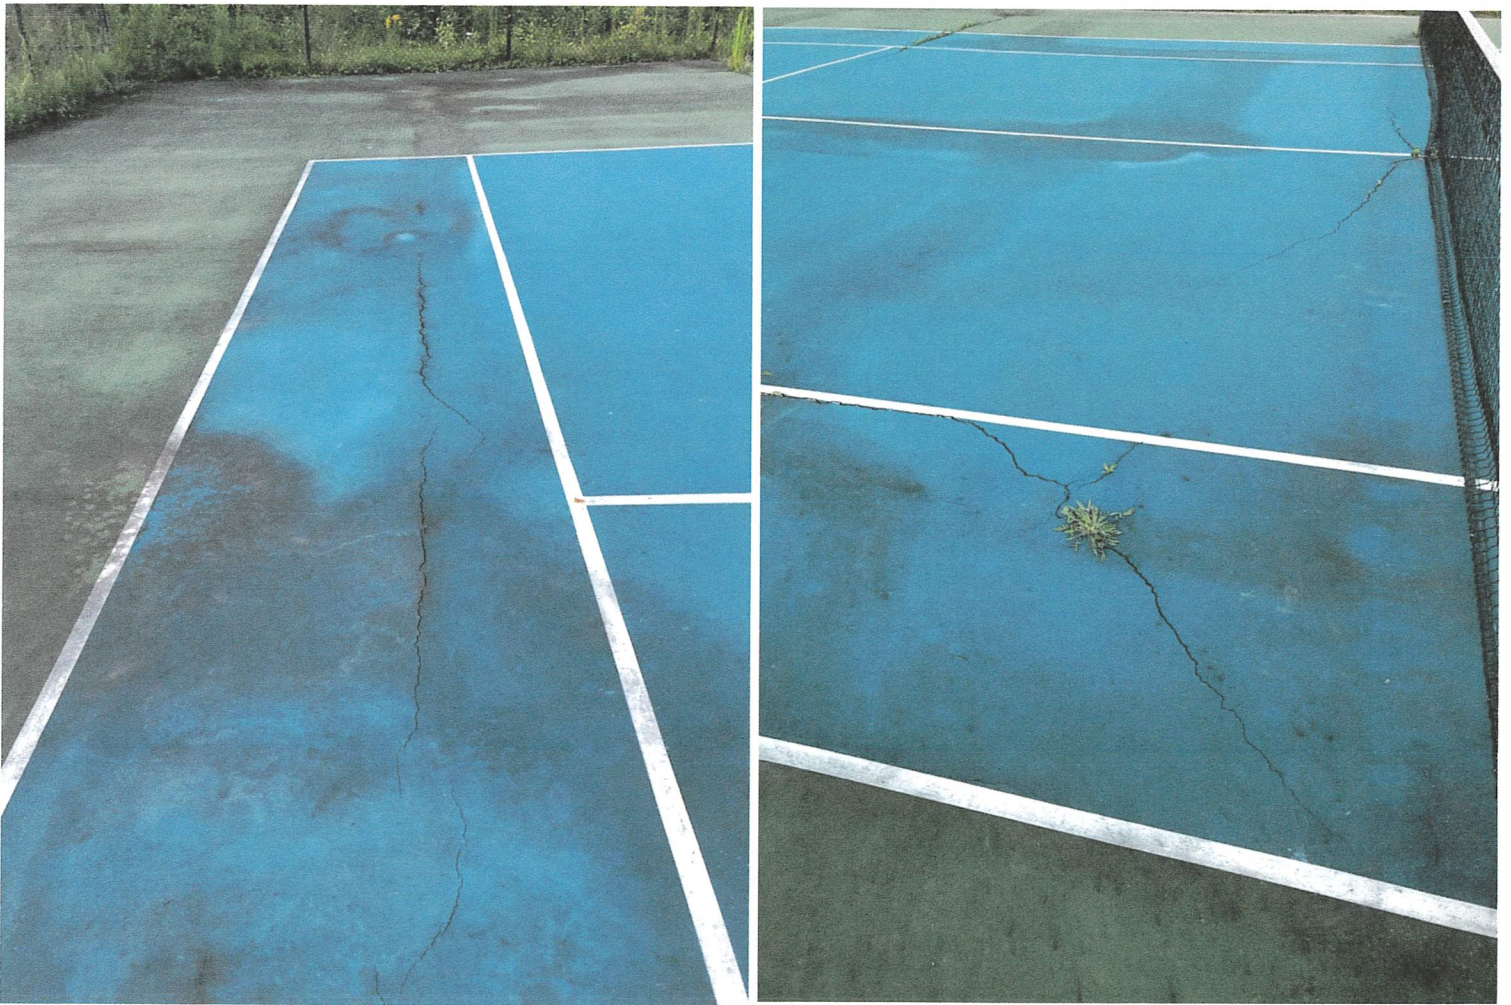
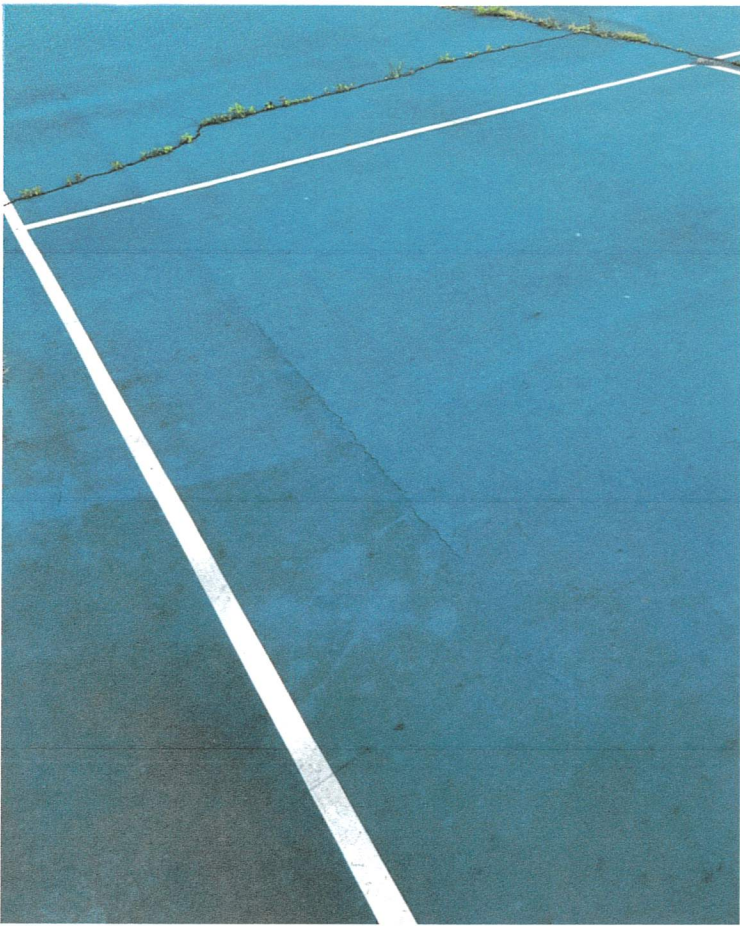
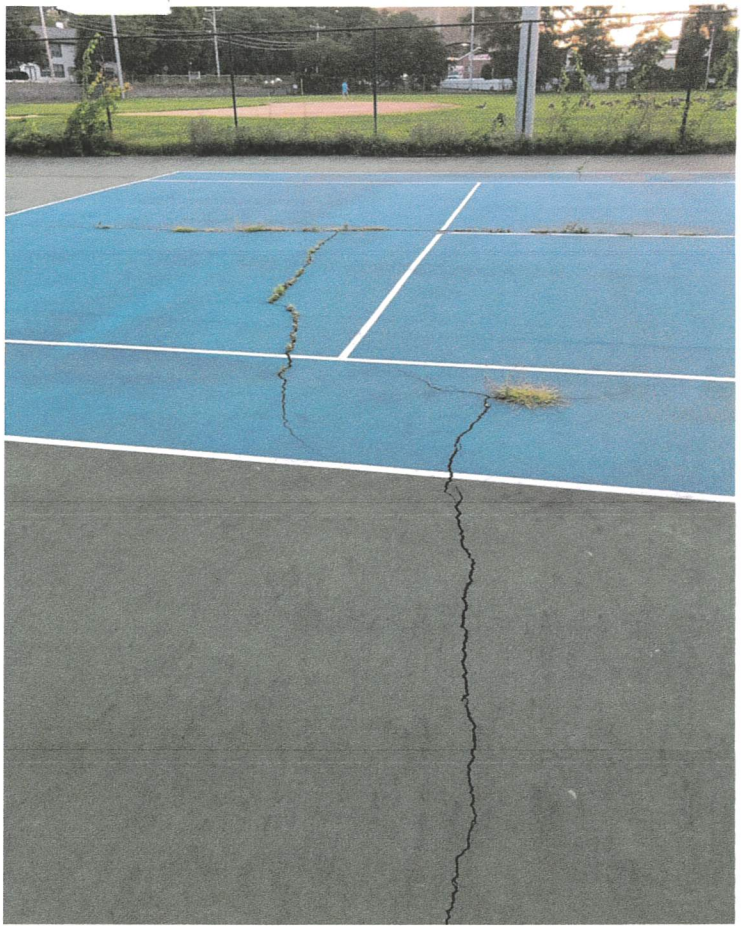
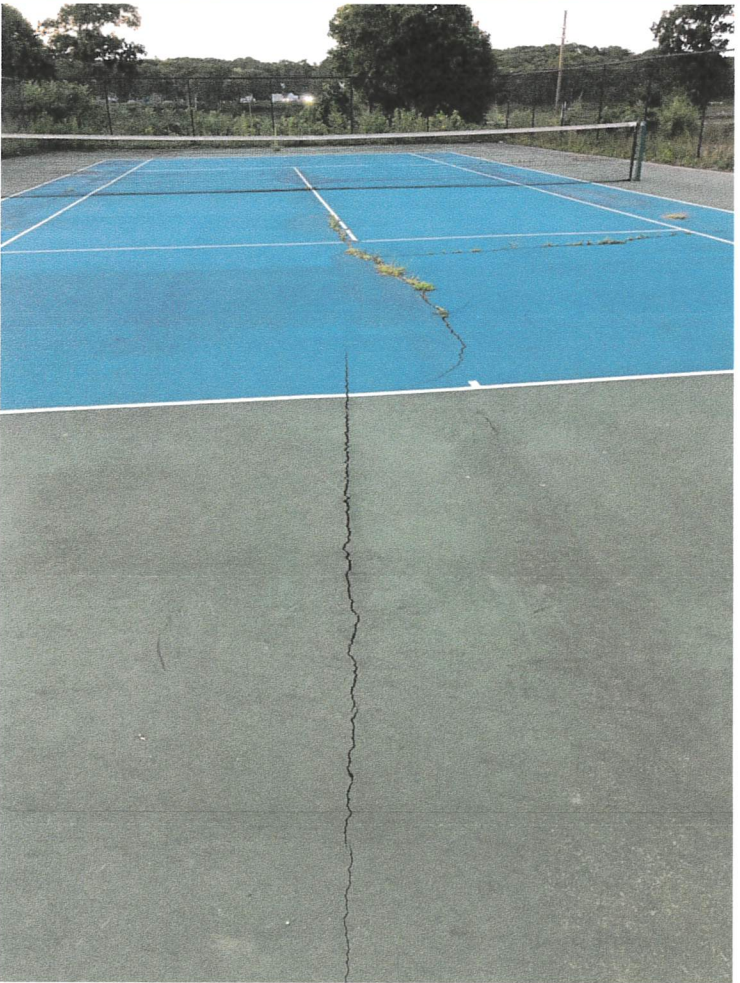
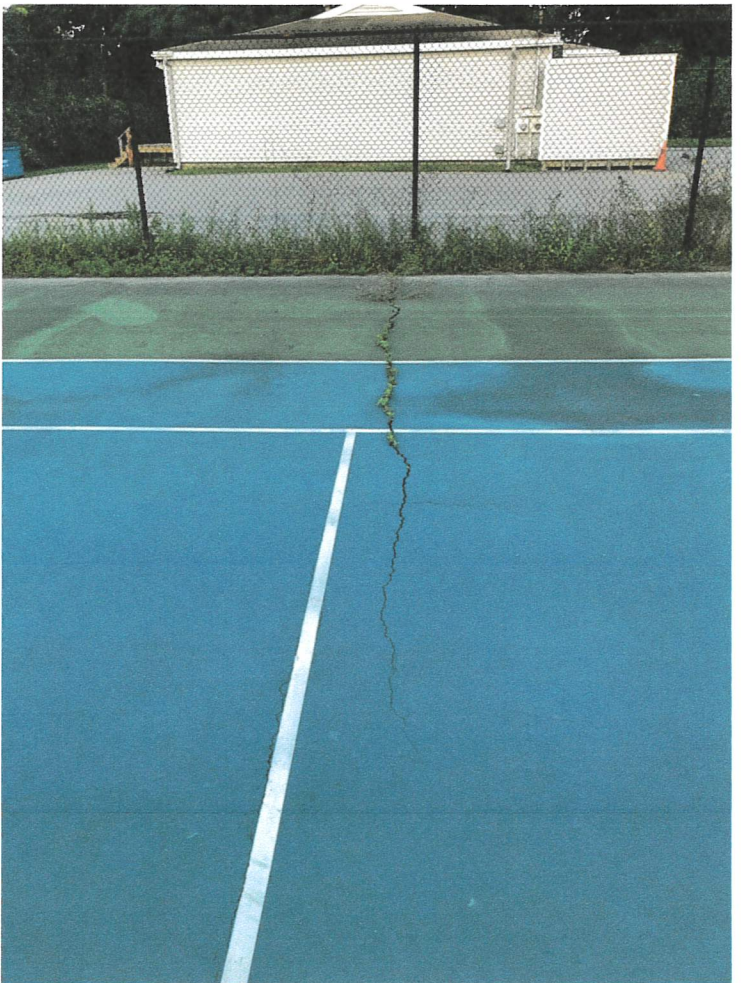
The Keith Field court is in poor condition. The court has 449 feet of cracks that require rehabilitation. There are also two “birdbaths” deep enough to warrant repair. Birdbaths are depressions that hold water after it rains and are usually considered worth repairing if their depth exceeds the thickness of a nickel. Tennis courts that have more than 500 linear feet of cracks are considered “not worth repairing” and this court is just under that. The fence is in fair condition. The asphalt has failed to the point where strong consideration should be given to refurbishing it again. Nevertheless, it is under the threshold and “could” be rehabilitated. Expected life remaining in the courts is no more than three years. The 2021 budget pricing cost to rehabilitate this tennis court is \$30,300.

On a ten-point scale:

Asphalt Condition: 1

Surface condition: 2

Fence condition: 4

Parking: 8

Demand: 3

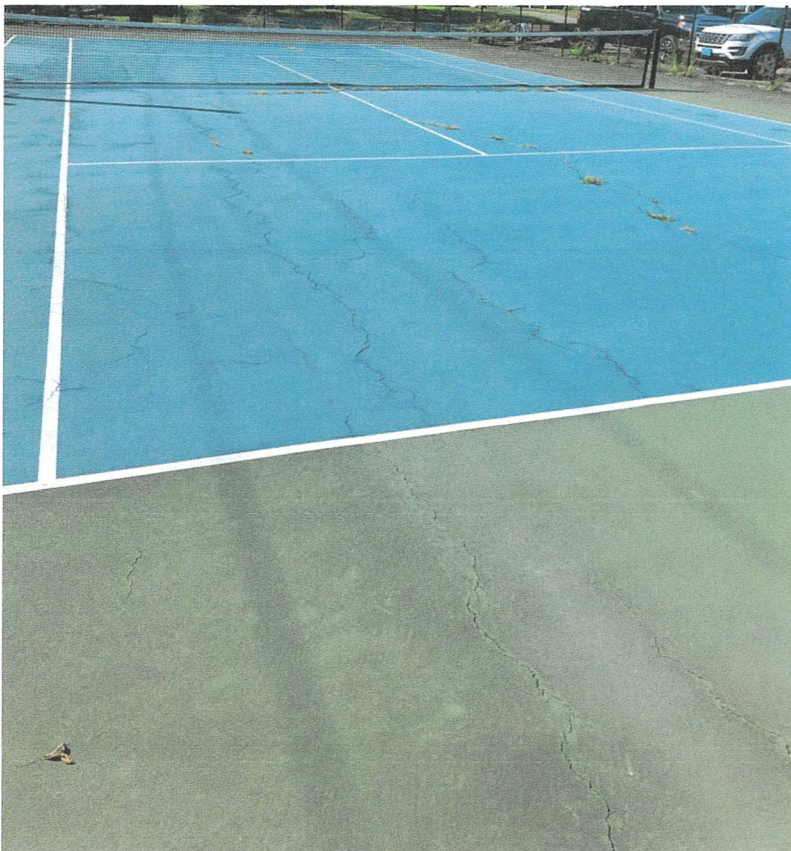
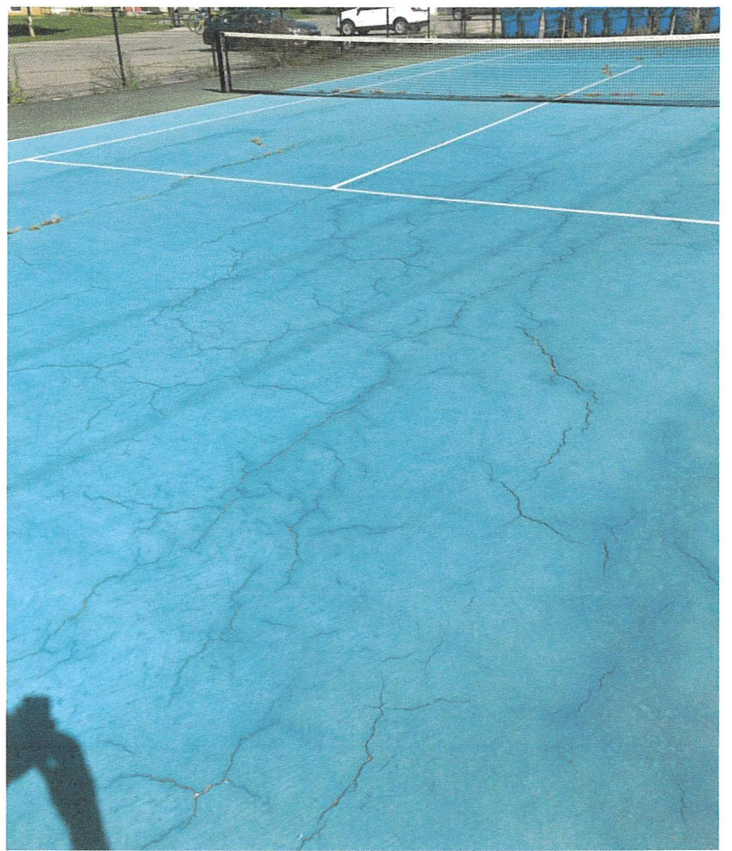
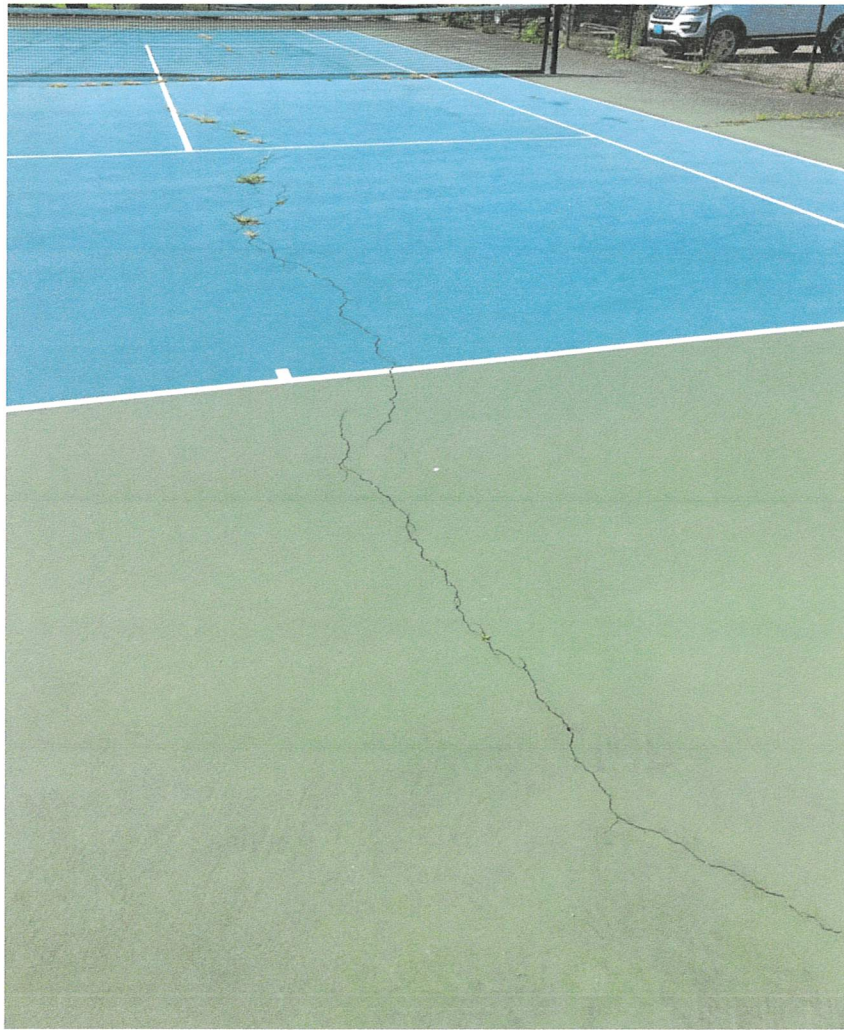
The Town Hall court is in poor condition. The fence is in fair condition and although old, is still functioning with both gates still working. The tennis court has extensive cracking and the asphalt has failed to the point where it is no longer economical to rehabilitate it. Expected life remaining in the courts is zero years. There is more than 500 linear feet of cracking on the surface so no pricing was given for the rehabilitation of this court.

On a ten-point scale:

Asphalt Condition: 1

Surface condition: 2

Fence condition: 6

Parking: 10

Demand: 2

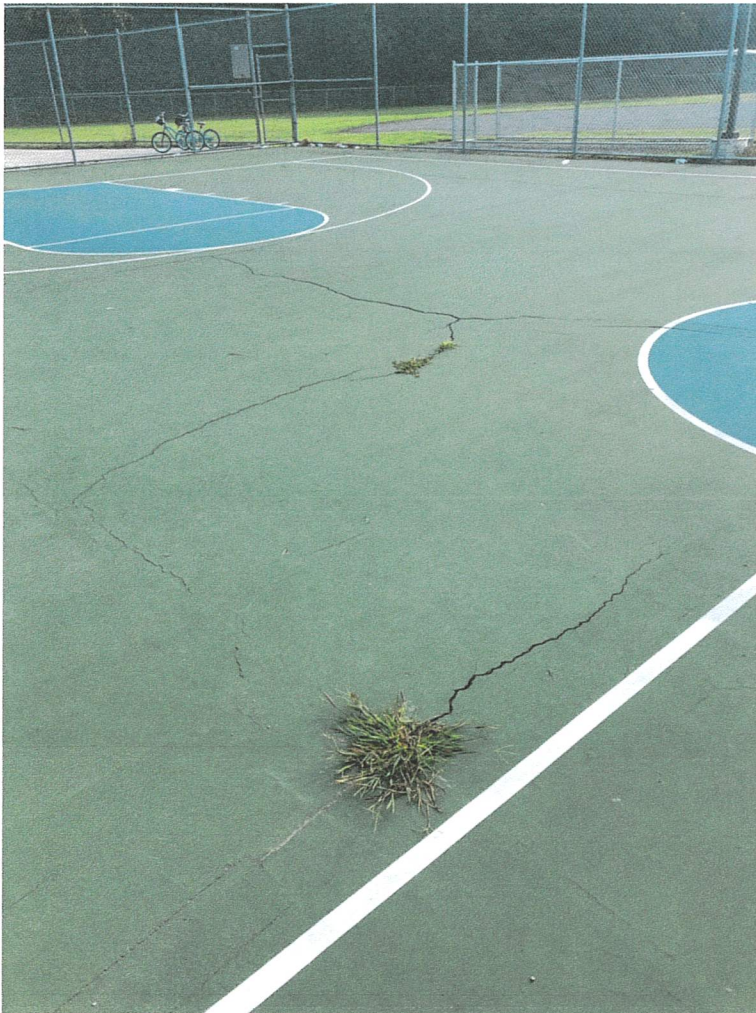
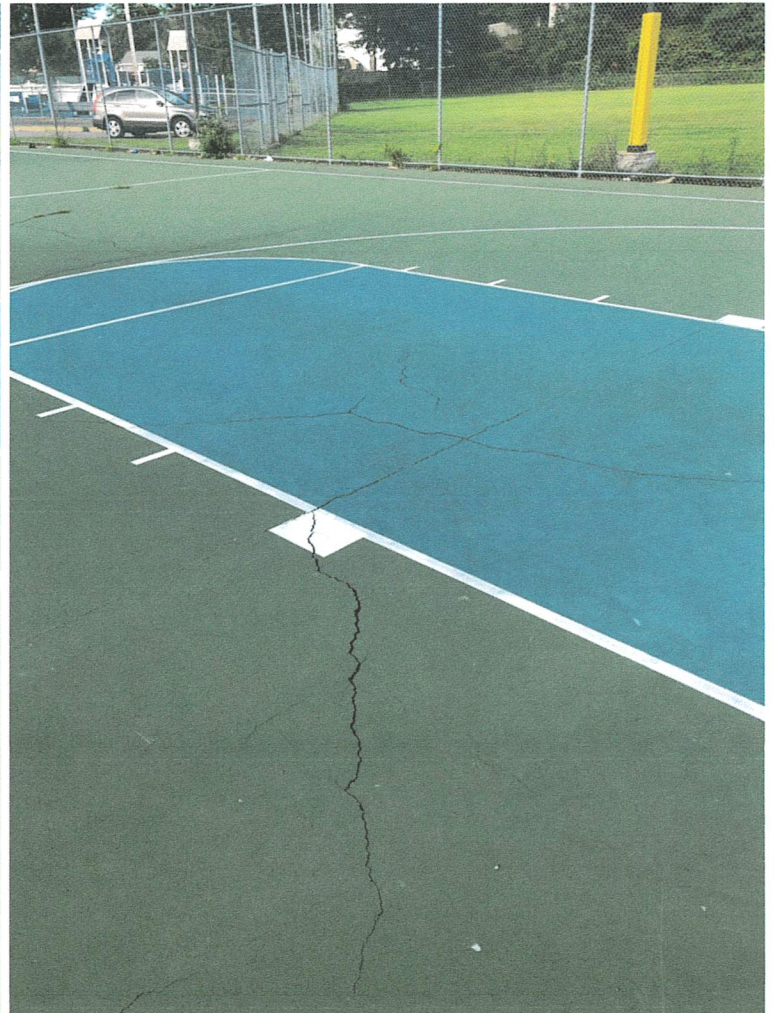
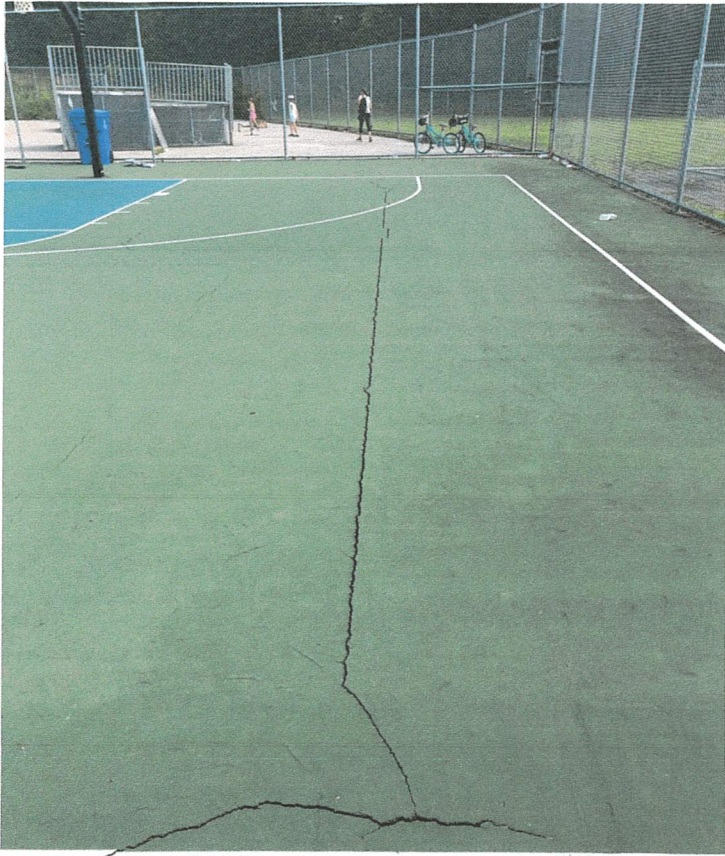
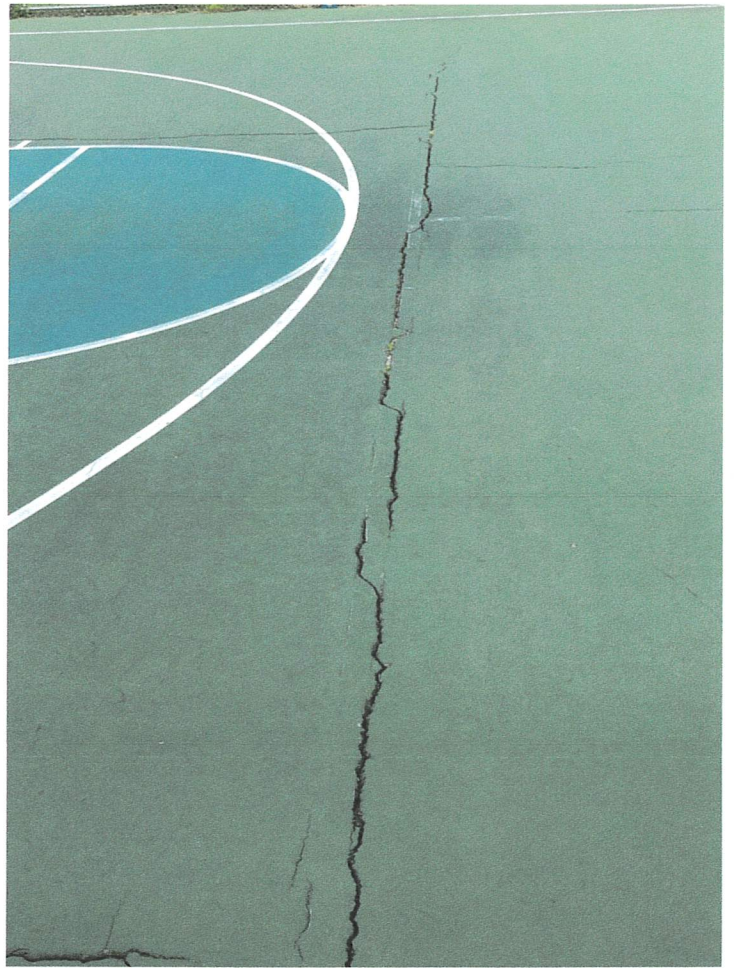
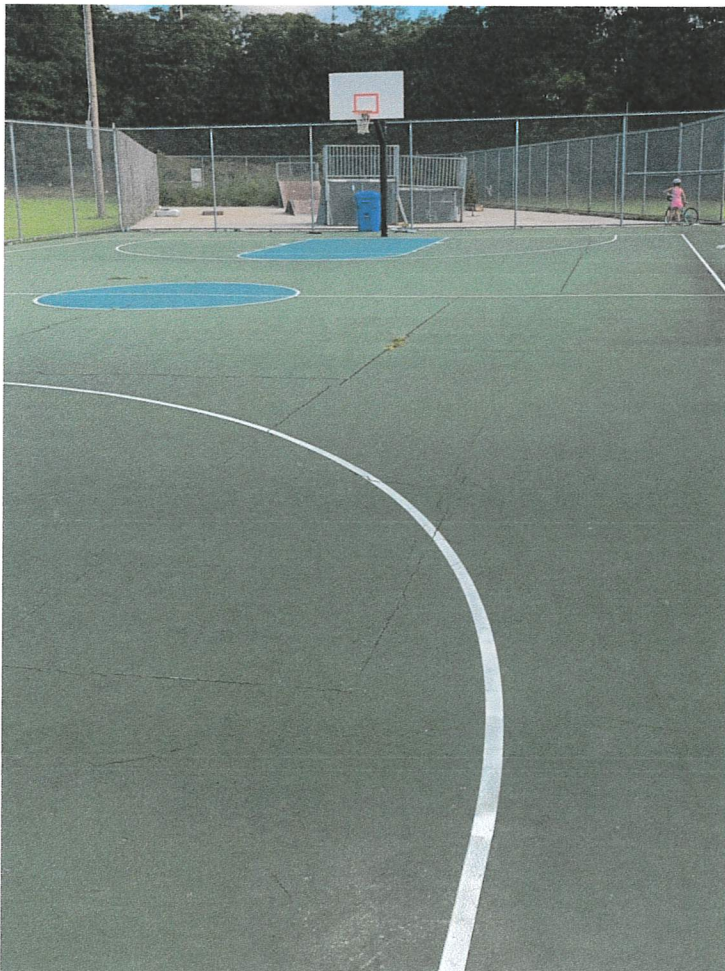
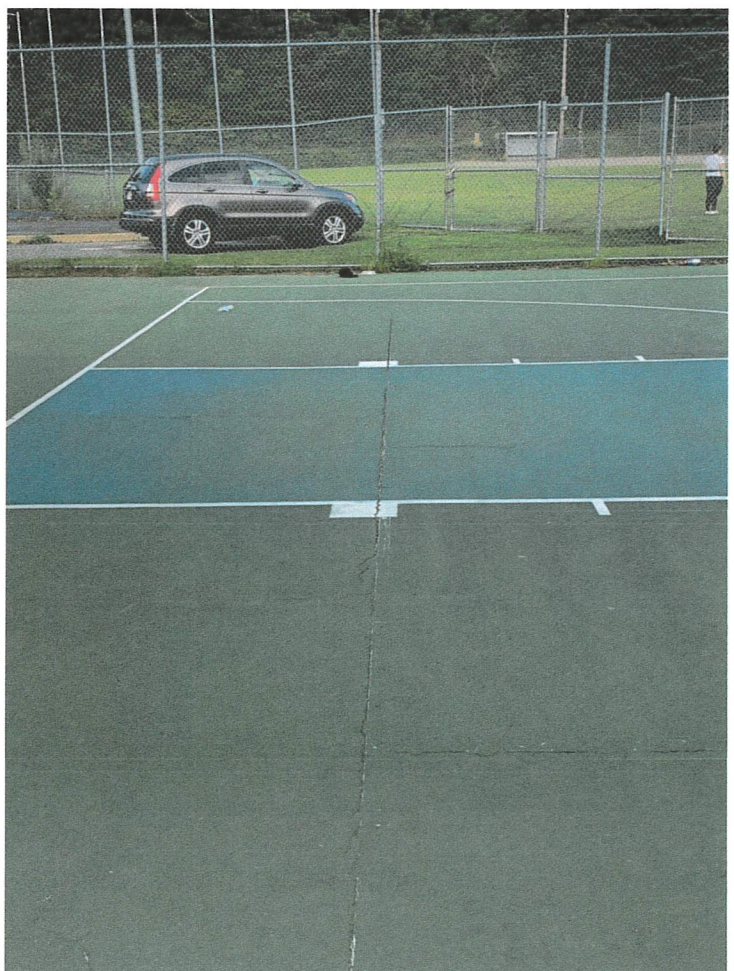
The Community Building Basketball court has extensive cracking with over 500 linear feet of cracks that are approximately ½" wide. The asphalt is failing and has already been repaired at least once and those repairs are also failing. This court should be scheduled for replacement as soon as funds allow as it is not worth rehabilitating. The fence is in excellent condition. The 2021 budget pricing cost to replace the basketball court is \$75,000.

On a ten-point scale:

Asphalt Condition: 3

Surface condition: 5

Fencing: 10

Parking: 10

Demand: 10

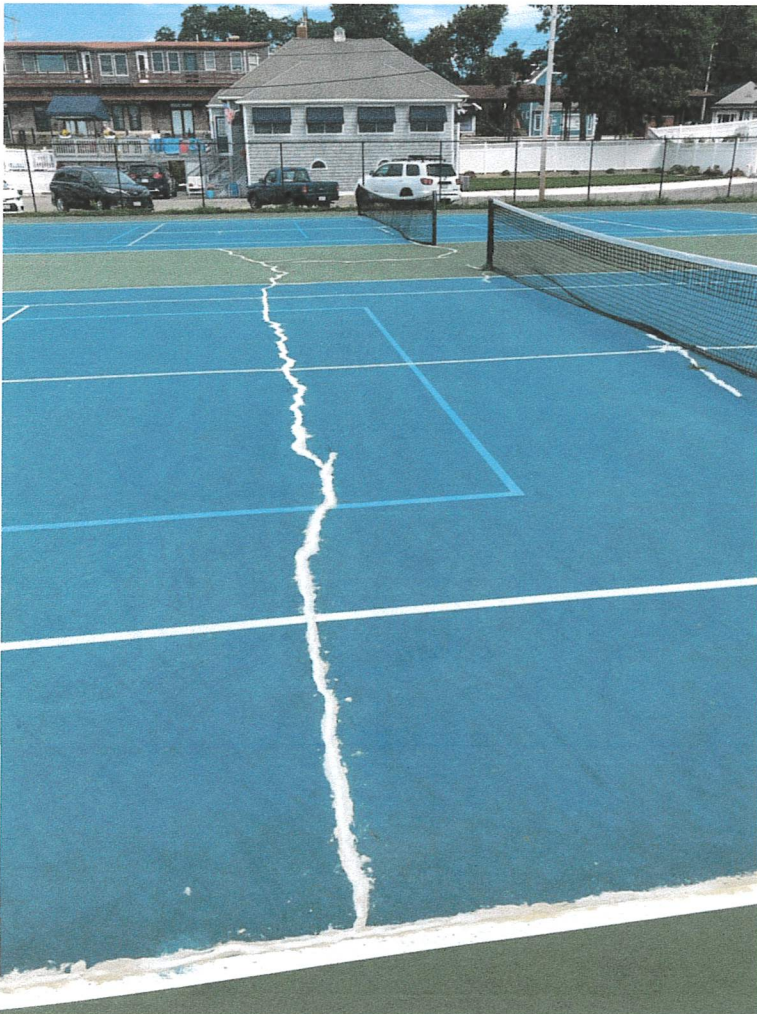
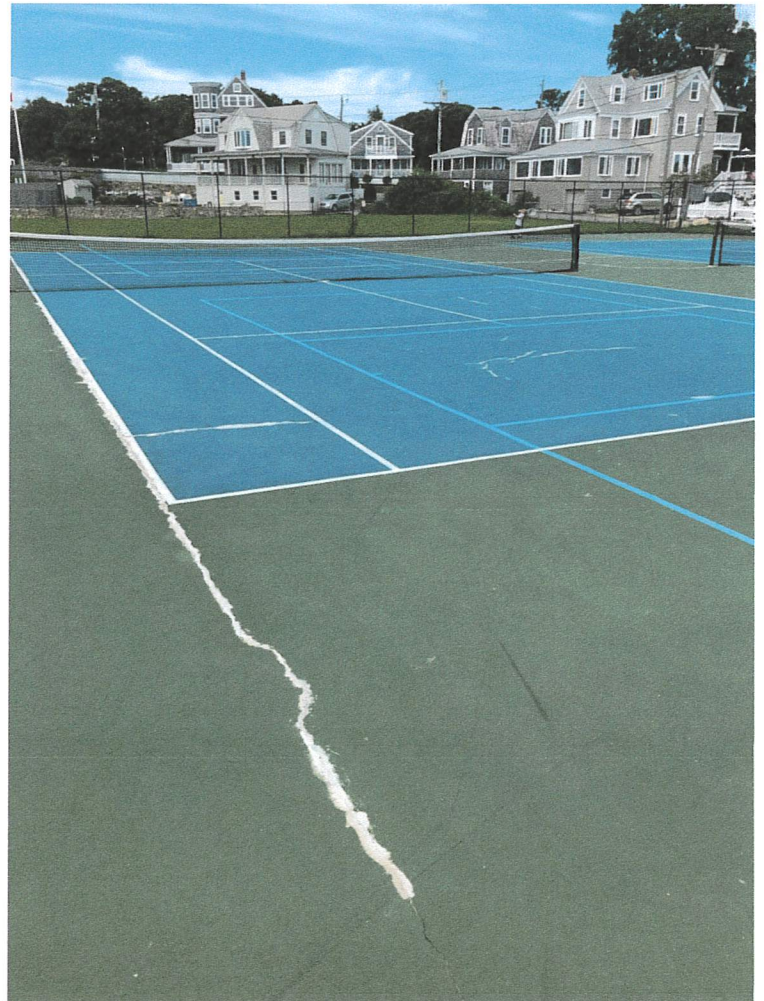
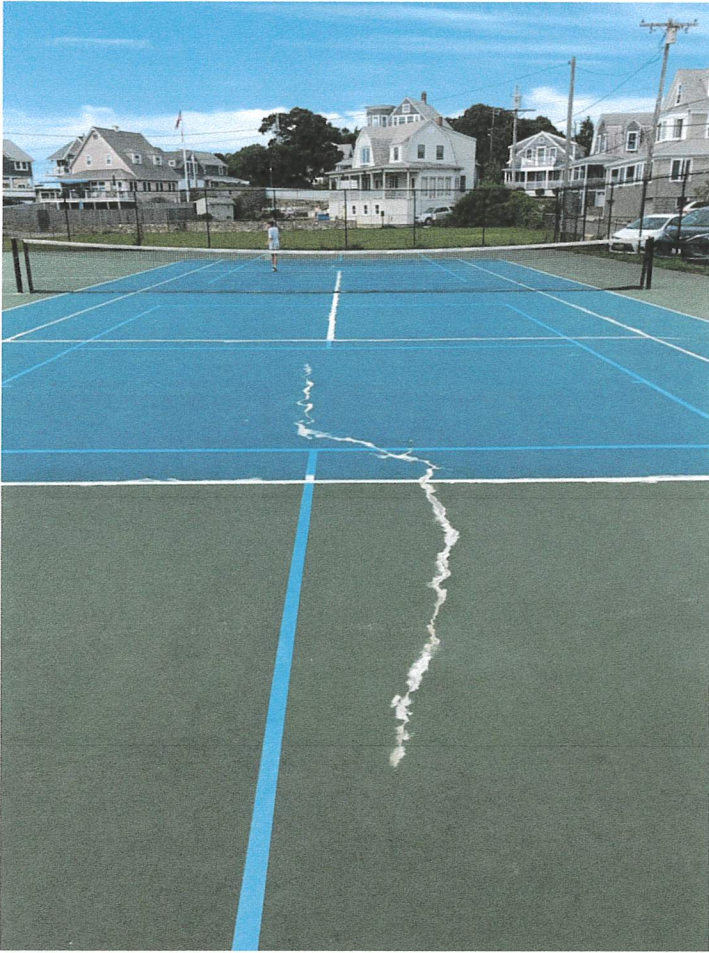
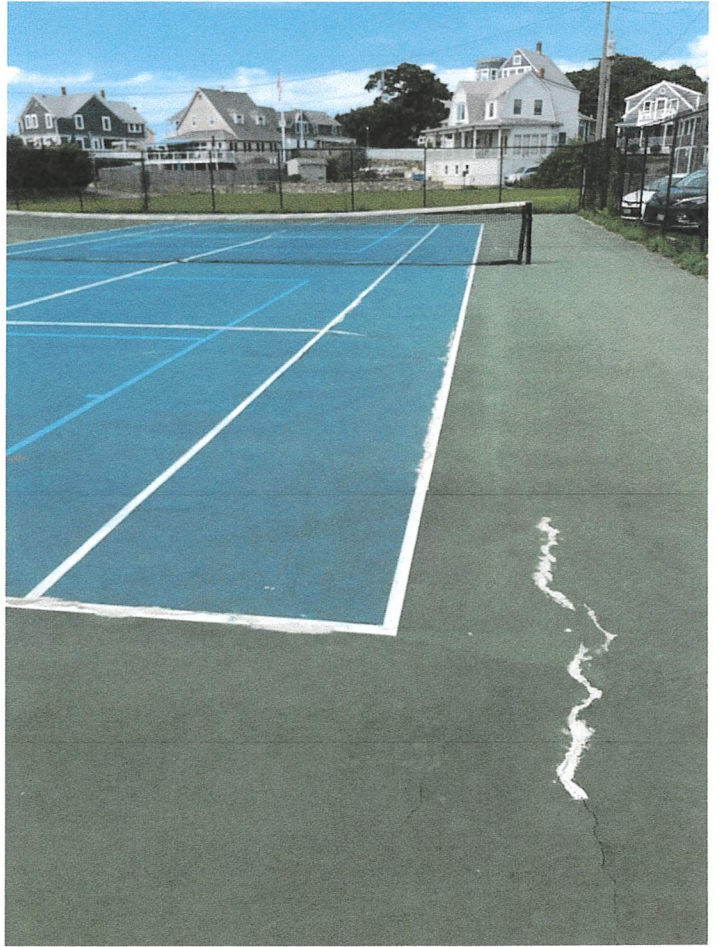
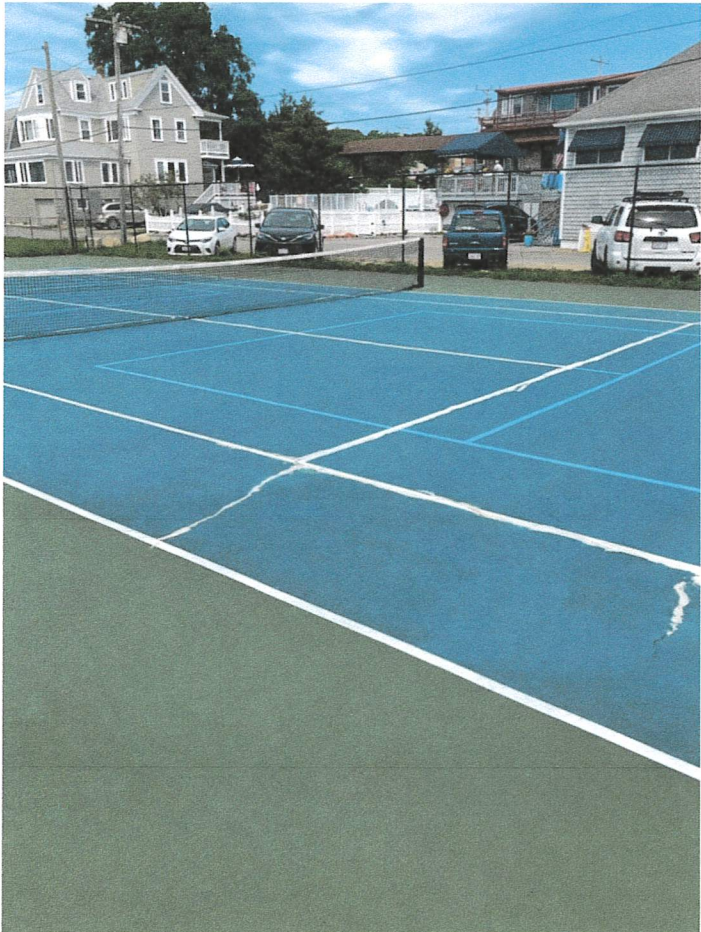
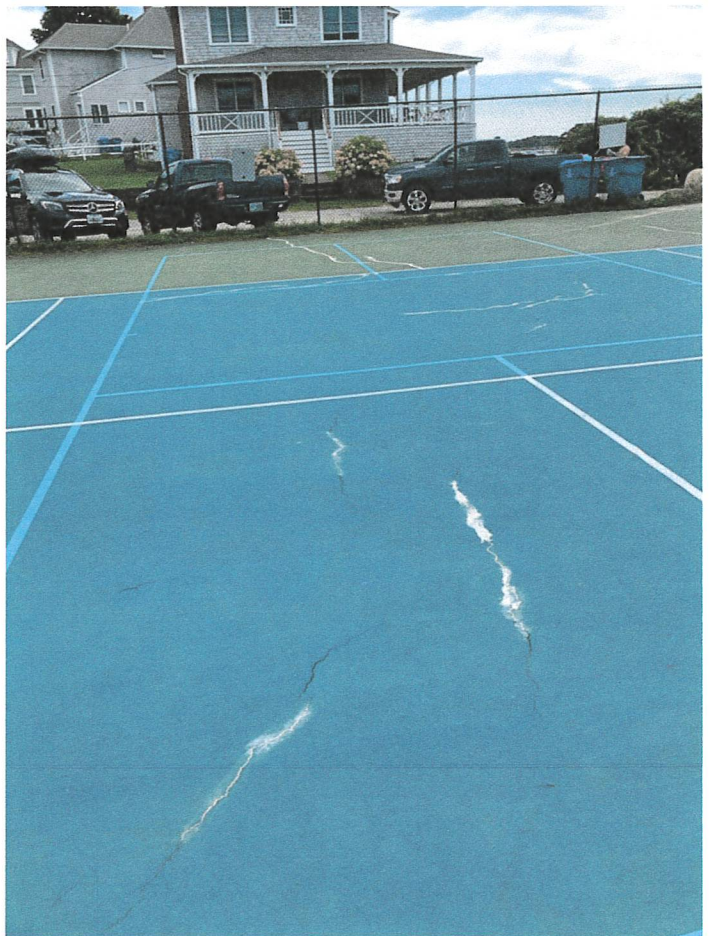
The Monument Beach courts are in poor condition despite Bourne DPW's valiant attempt to temporarily fill the cracks. The width of the cracks indicates asphalt failure that is beyond any economical ability to rehabilitate. The fence is in good condition. Both tennis courts have significant cracking some of which is evident in pictures below in white crack filler. Cracks wider than 3/8" are beyond the bonding of crack filler and will fail again quickly. The temporary repairs affected by the DPW will extend the expected life of the courts for perhaps another year but the extensive cracking of that width makes it beyond refurbishing. Strong consideration should be given to not replacing any hard court on that location that is not post-tensioned concrete. The proximity to the beach and its potential for serious storm damage would make the "base" subject to undermining which would make any asphalt construction short lived.

On a ten-point scale:

Asphalt Condition: 2

Surface condition: 3

Fence condition: 7

Parking: 5

Demand: 8

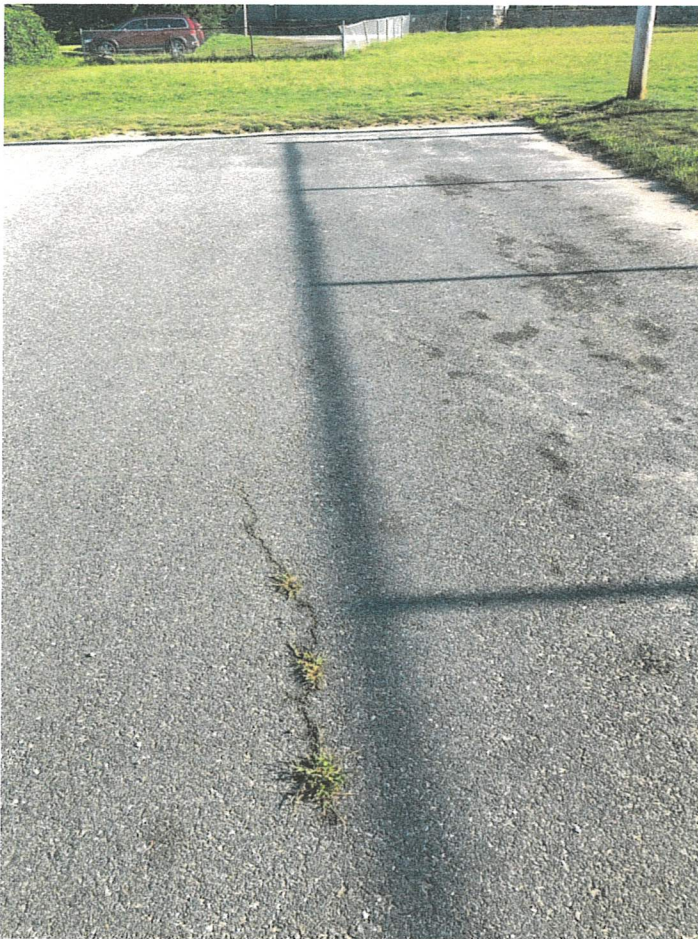
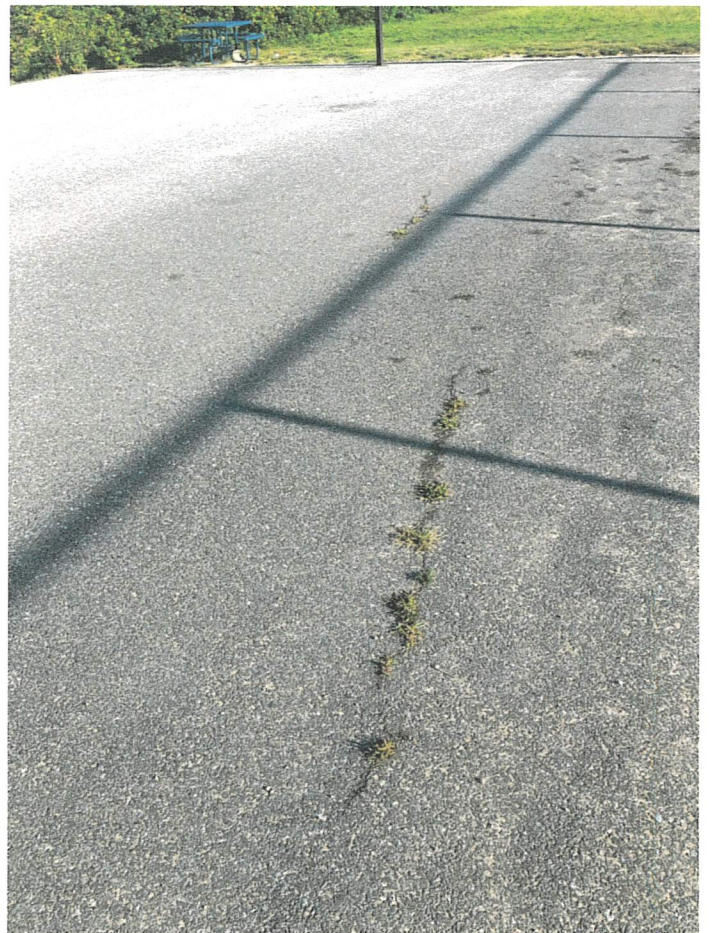
The Monument Beach Basketball court is in good condition. There is some asphalt cracking that is starting but it is minor and not in need of rehabilitation yet. There is no fence. The court has no protection against blowing sand and is often covered in sand making play difficult. Nevertheless, there are people playing there regularly and it remains in demand. The courts proximity to the beach makes it a poor site for long term asphalt construction as the base is in constant danger of erosion. It may be worth considering meeting with representatives of the Monument Beach Civic Association and ask for their input on how best to provide a better location for a neighborhood basketball court.

On a ten-point scale:

Asphalt Condition: 7

Surface condition: N/A

Fence condition: N/A

Parking: 5

Demand: 8

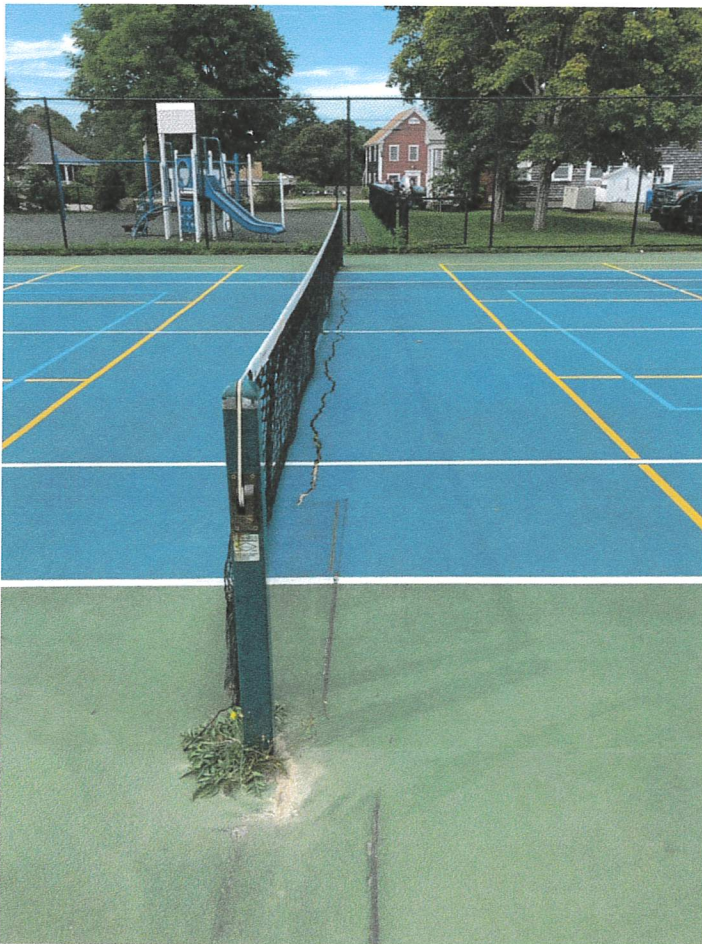
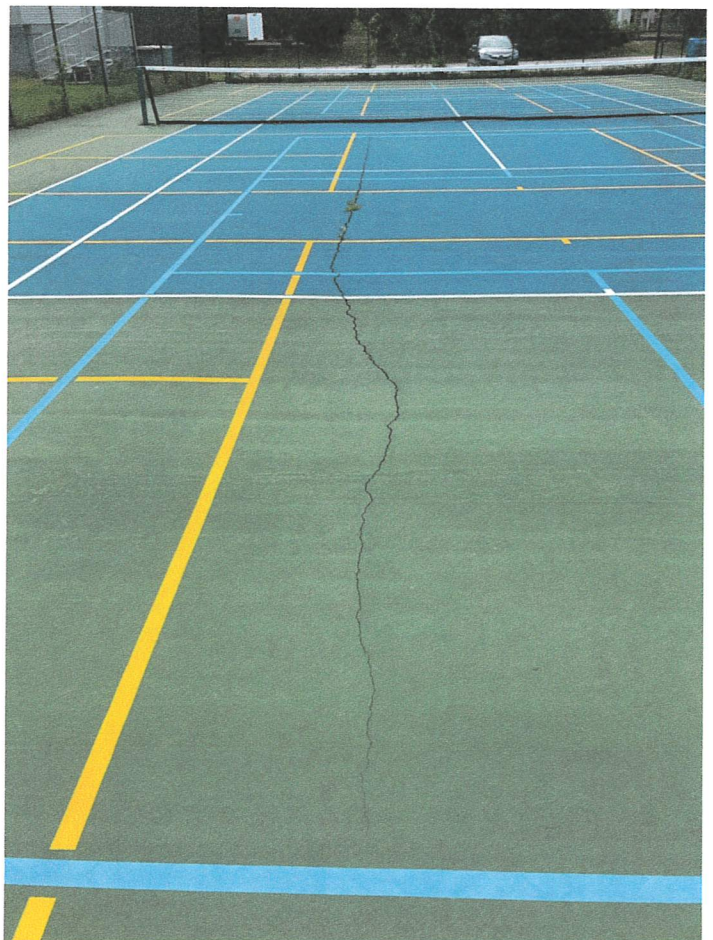
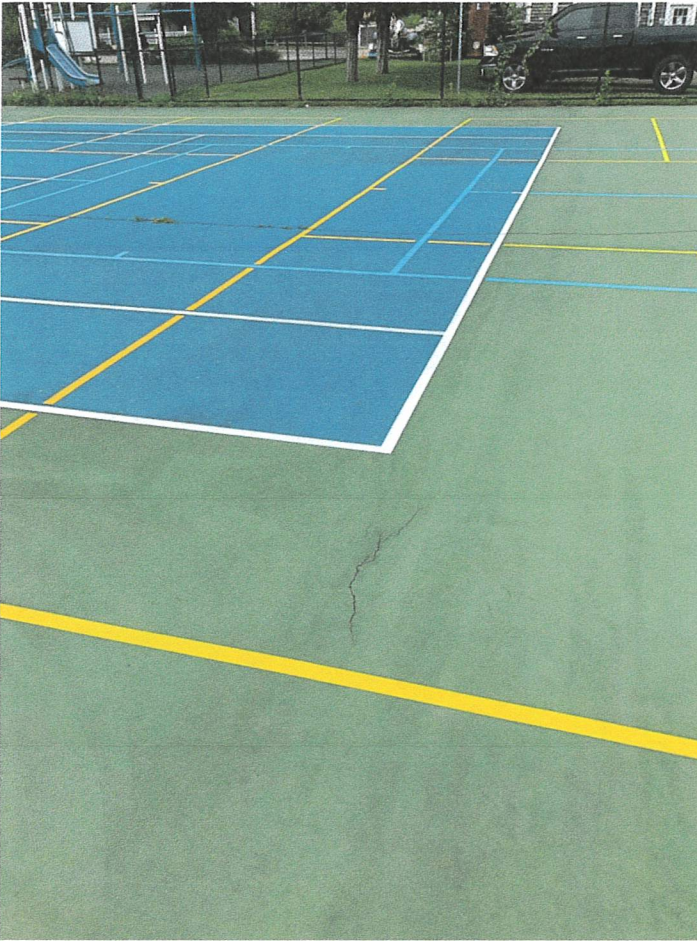
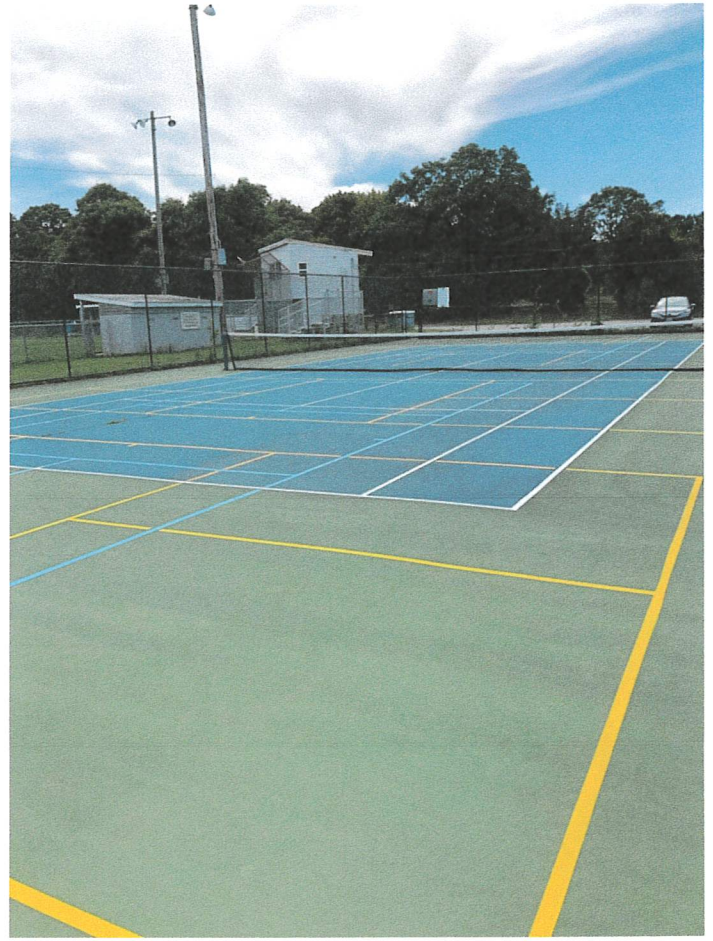
The Pocasset tennis court is in fair condition. There is 136 linear feet of cracks that need rehabilitation. Of somewhat larger concern is the “heave” that is coming up at the net line. Something below is pushing up the court in that area and it is difficult to know what is causing that without excavation. The court is striped for other events and heavily used. There are some previous repairs that will have to be removed to affect the new refurbishing. The fence surrounding the court is in good condition. The asphalt is starting to fail but is still at a point where the condition could be extended several years by rehabilitating the surface and recoating. Expected life remaining in the courts is approximately five years. The 2021 budget pricing cost to rehabilitate this court is \$21,000.

On a ten-point scale:

Asphalt Condition: 6

Surface condition: 7

Fence condition: 8

Parking: 9

Demand: 9

The one unknown in the pricing is the heaving area. Cutting out the asphalt in that area and excavating the cause and filling with concrete is the best way to proceed. The cost to do this is unknown but we would estimate a cost of at least \$5,000. It may be worth pointing out that the DPW could do these refurbishments leaving the surfacing to others and save a great deal of money if their time allows.
