# Bourne Hard Court Evaluation and Rehabilitation Plan

This report is submitted to drive improvements in the basketball and racquet sports facilities in the Town of Bourne. Racquet sports to include both tennis and pickleball.

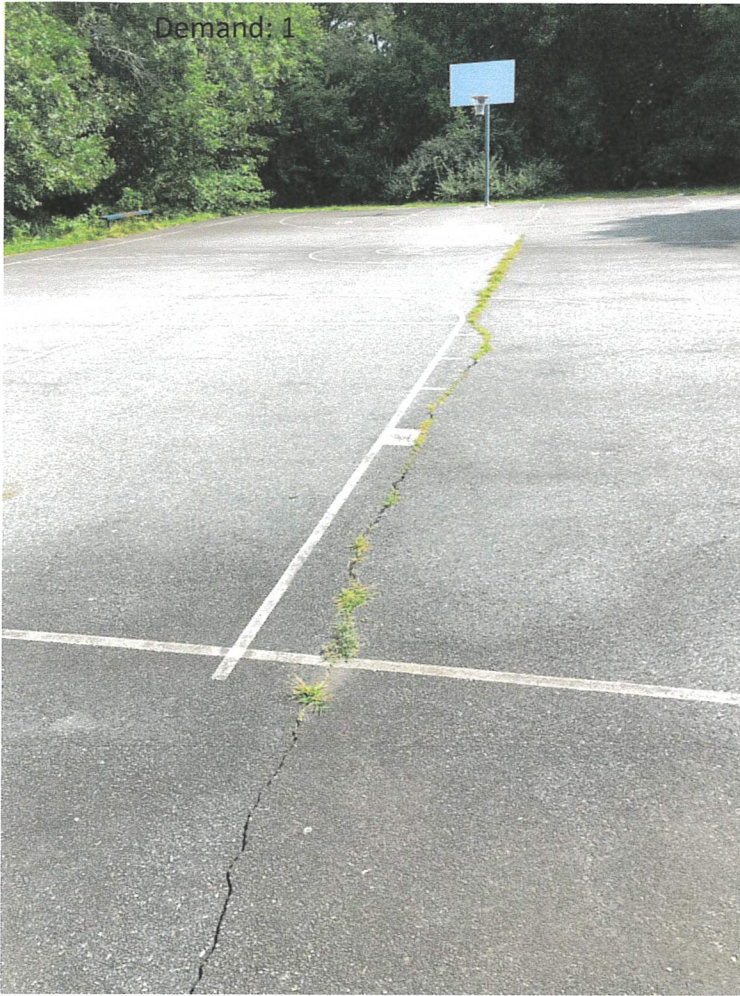
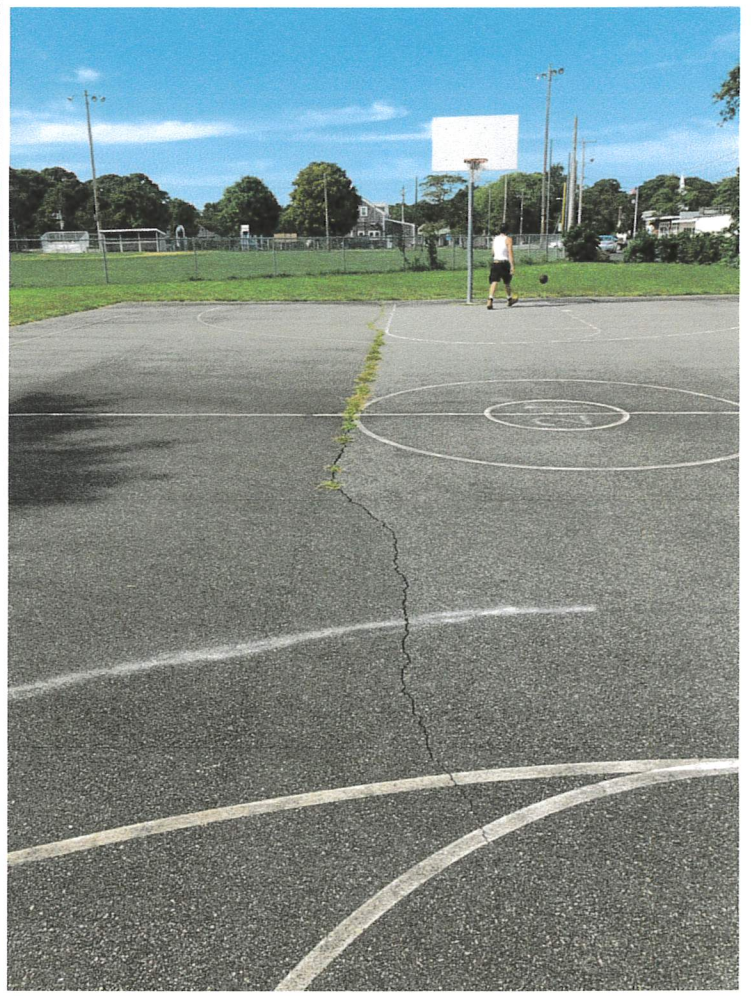
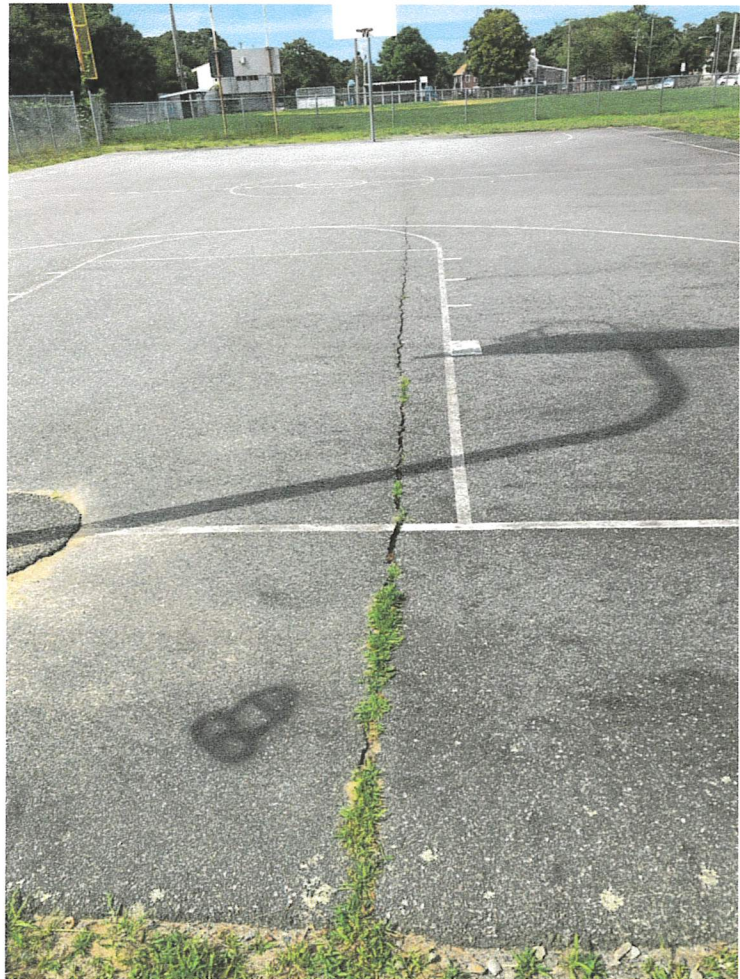
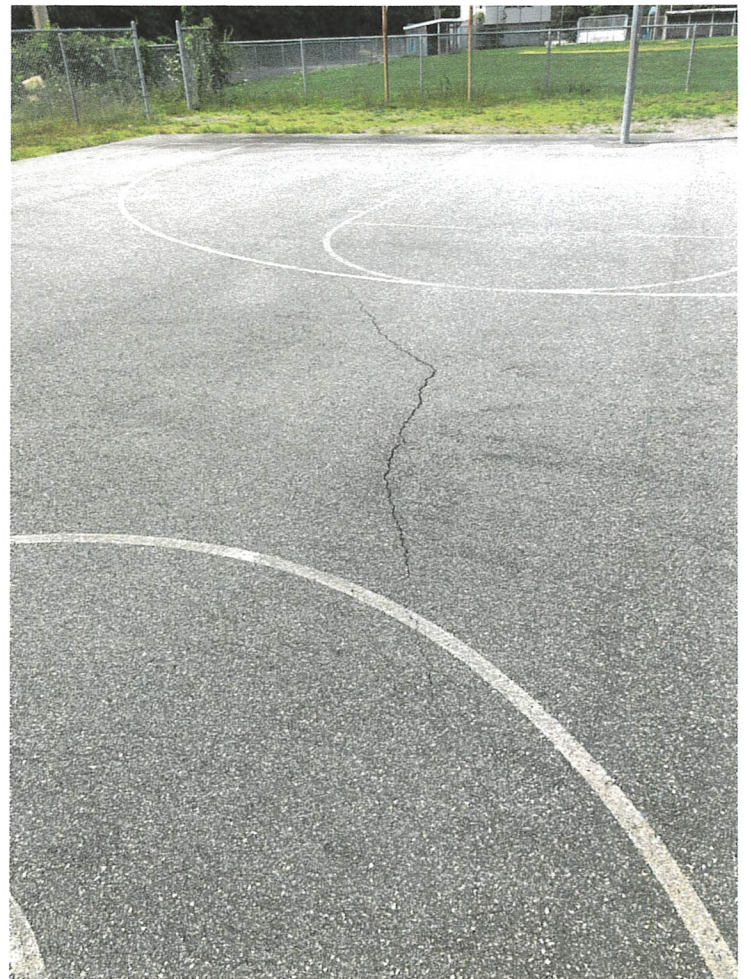
The Pocasset Basketball courts dedicated to David Duca are in fair to good condition. There is 328 linear feet of cracks that could be rehabilitated but the lack of surfacing on these courts makes that less imperative. The asphalt is not raised on either side of the cracks so should not present a trip hazard and the courts are used sparingly and then mostly by single players for “shooting practice”. The asphalt is starting to fail but the cracks are mostly confined to the asphalt seams from the paver. This usually means that the cracks will get worse slowly. Expected life remaining in the courts is approximately five years. No pricing was offered for repair because none appears necessary.

On a ten-point scale:  
Asphalt Condition: 6  
Surface condition: N/A  
Fence condition: 4  
Parking: 2

Demand: 1

It is worth noting that grass encroaching on the cracks will accelerate the failure so treating the areas with a grass inhibitor would be helpful to extend the life. When it comes time to replace the fencing, a vinyl fence fabric would be desirable to slow the rust which is affecting the existing fence.

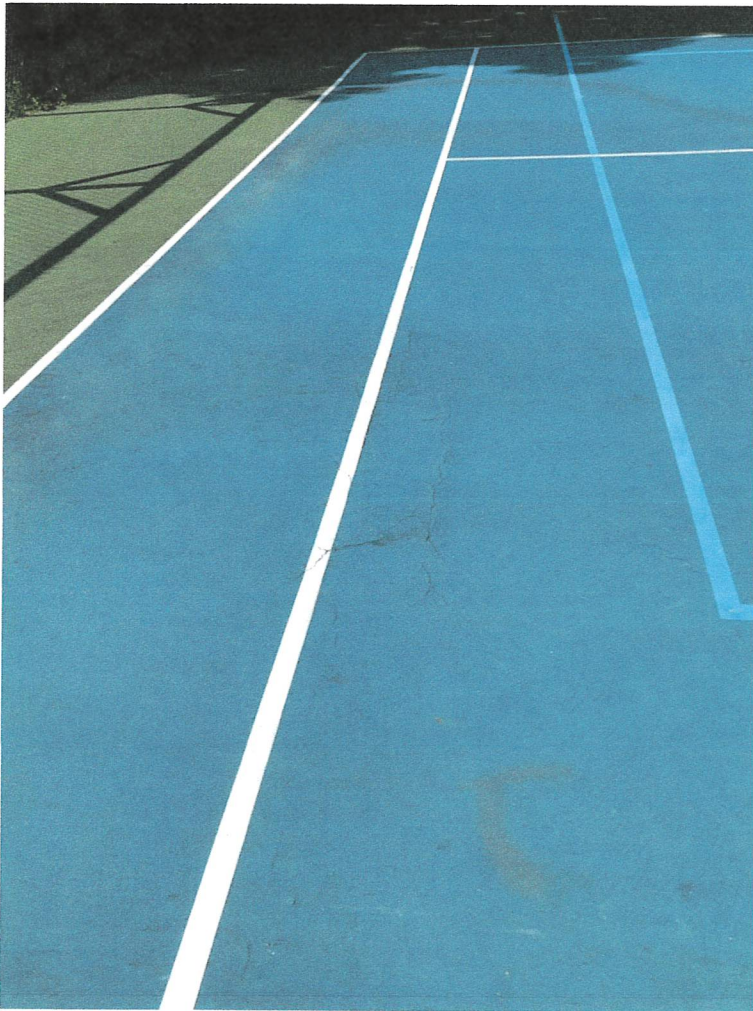
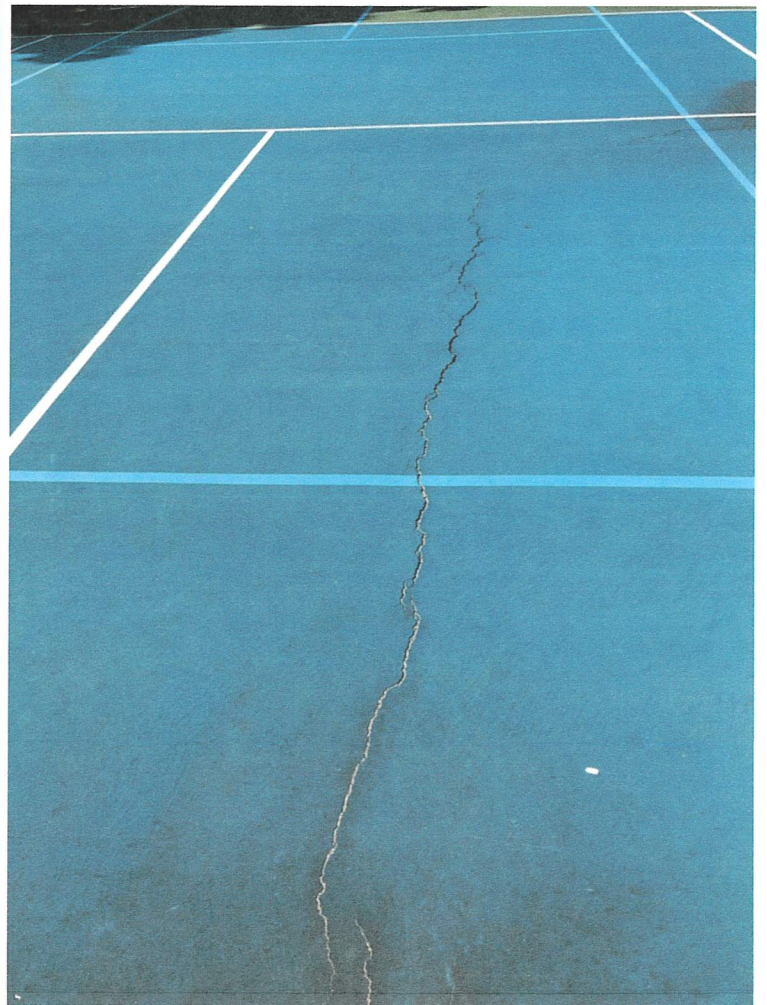
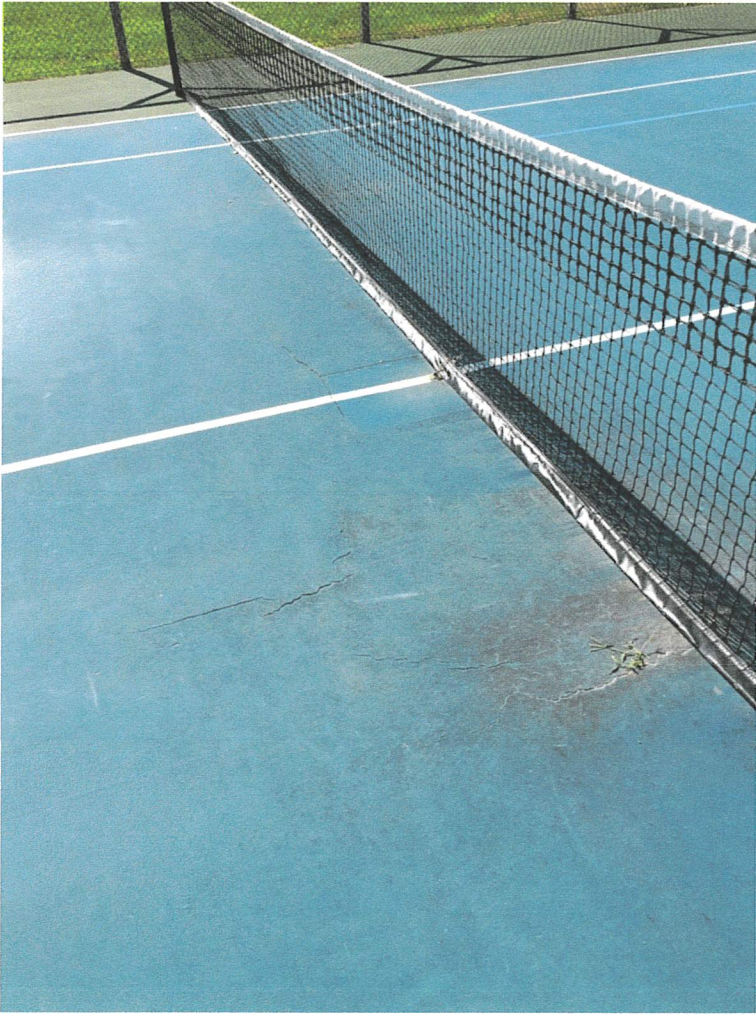
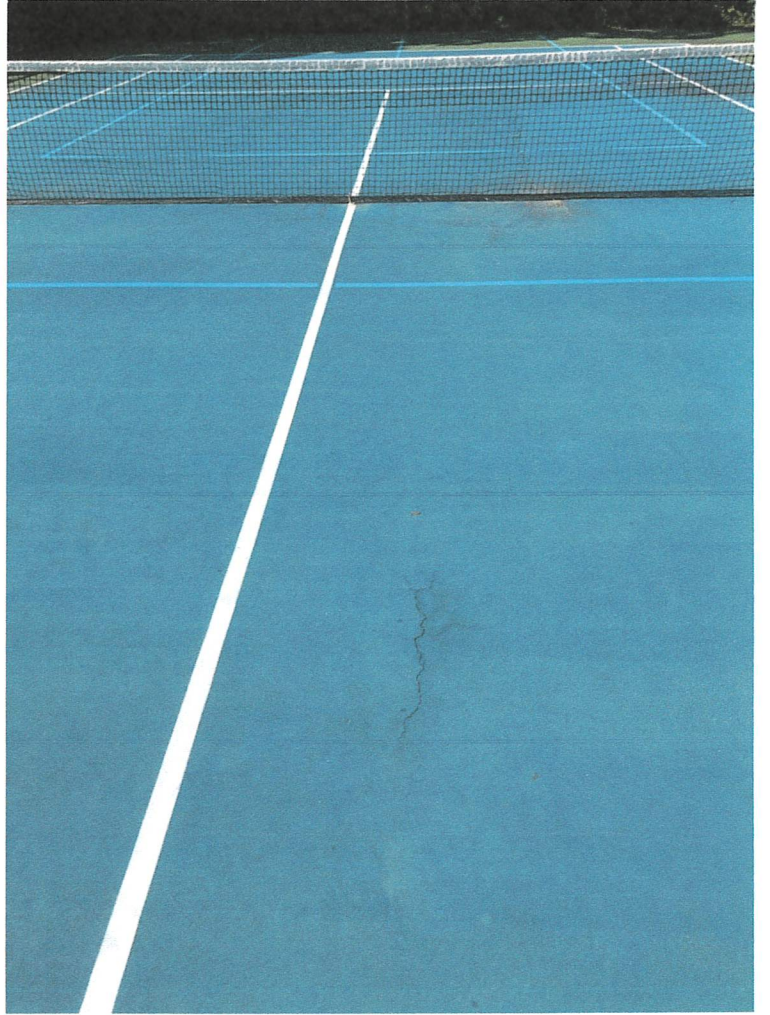
The Cataumet Schoolhouse tennis court is in fair to good condition. There is 187 linear feet of cracks that need rehabilitation and three birdbaths. The court is striped for other events and heavily used. There is one previous refurbishment that will have to be removed to affect the new rehabilitation. The fence surrounding the court is in fair condition but in keeping with the village aesthetics so nothing should be done to disturb that. The asphalt is starting to fail but is still at a point where the condition could be extended several years by rehabilitating the surface and recoating. Expected life remaining in the courts is approximately four years. The 2021 budget pricing cost to rehabilitate this court is \$20,000.

On a ten-point scale:

Asphalt Condition: 5

Surface condition: 6

Fence condition: 6

Parking: 2

Demand: 7
